Service Information Bulletin

SUBJECT	DATE
DT12 Symptom Diagnostics - Transmission Failed Learn Procedure	June 2018

2 Transmission Learn Procedure Fails

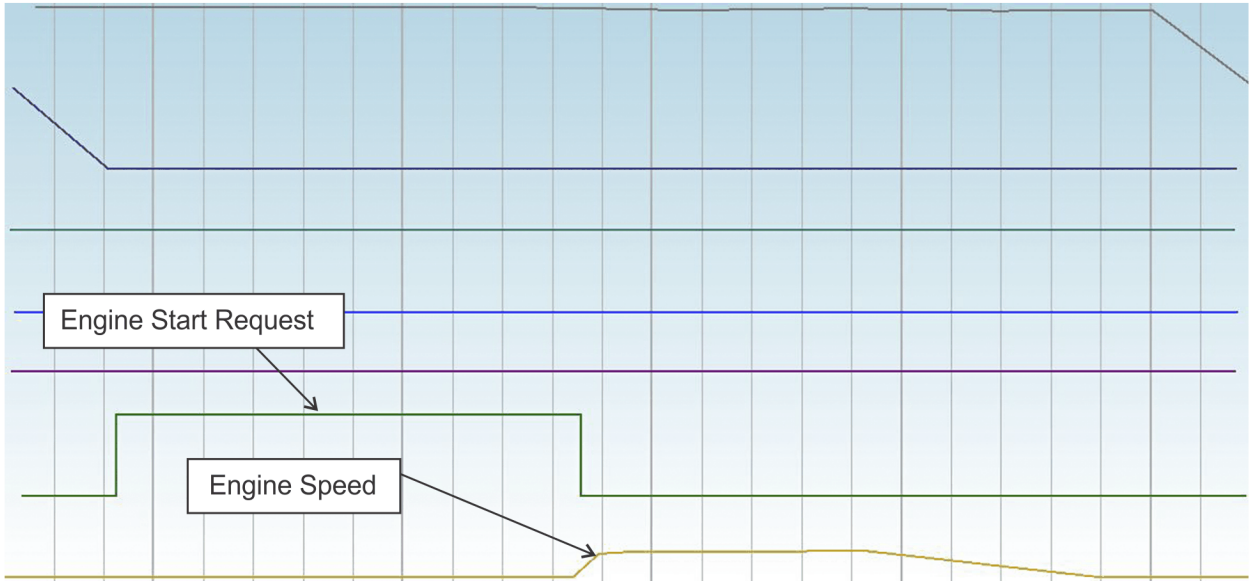
d500321

1. **There is a missed Engine Start Request.**

The engine start request lasts ten seconds. The engine was started after the engine start request went inactive. In this case, just attempt another learn procedure and follow the prompt to start the engine from the display in the dash, not from DiagnosticLink[®].

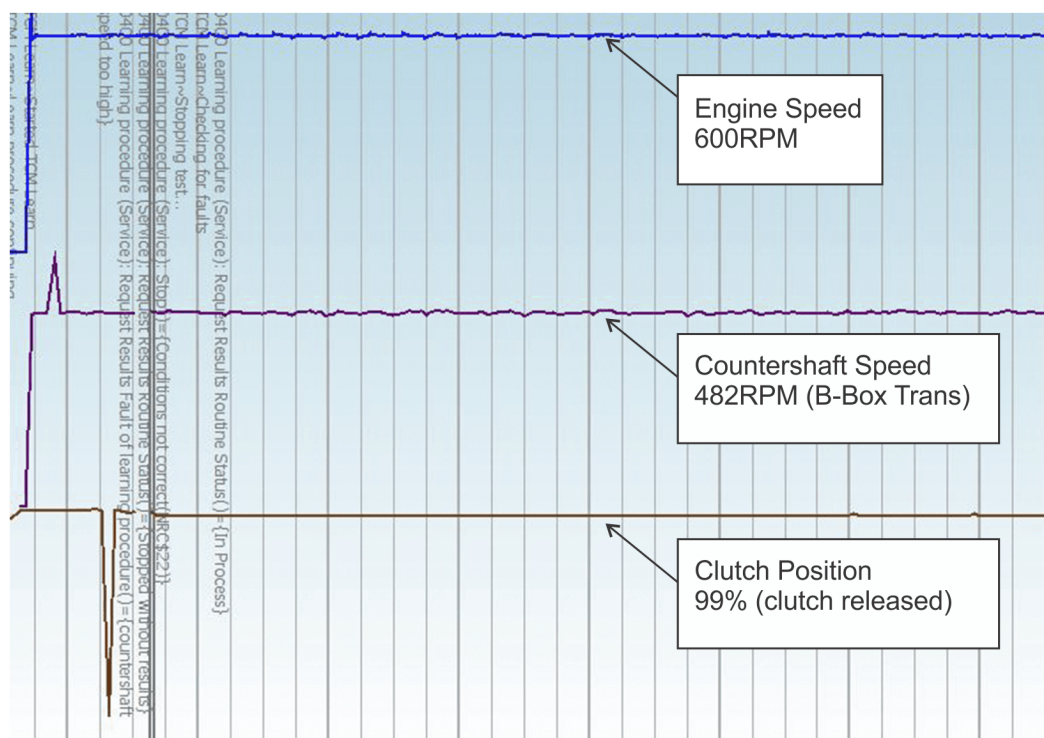
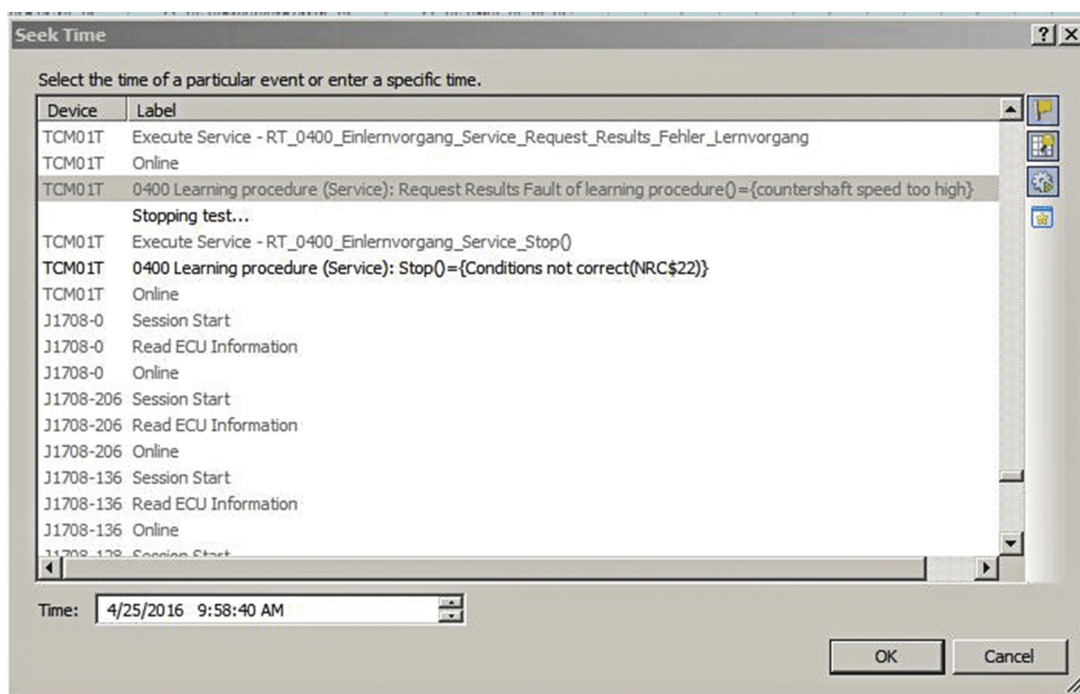
d500322

2. **Countershaft speed is too high.**

The label above reads "Request Results Fault of learning procedure () = {countershaft speed too high}". The pop-up below shows the label more clearly.

This indicates a possible issue with the clutch. Please refer to Clutch Inspection Symptom Diagnostics.

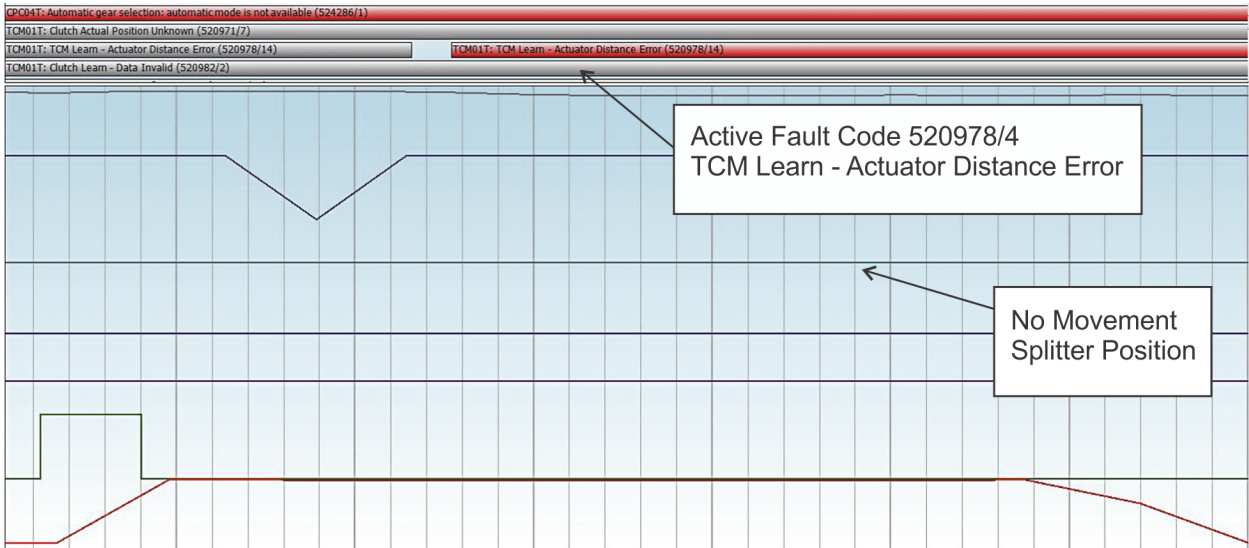
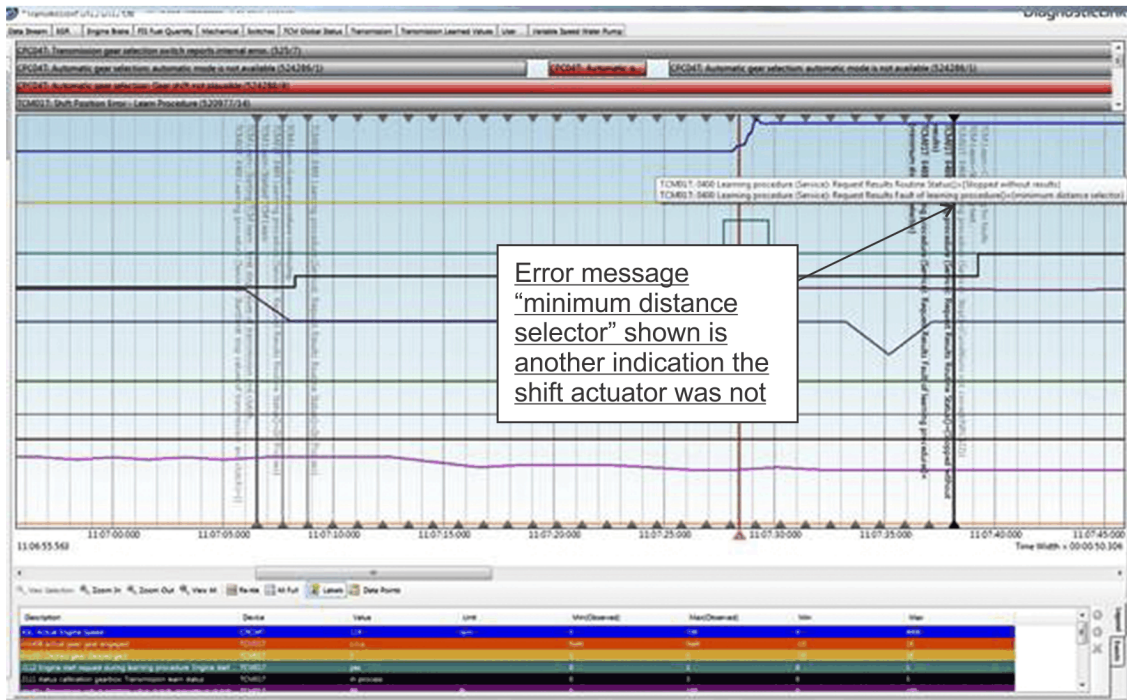
d500324

3. Shift Controller is installed incorrectly.

This condition will occur when the shift controller is removed for replacement or when completing the split pin bushing repair. When the shift controller is not hung correctly on the shift actuator or BOTH gaskets are not installed on the shift controller, the shift actuator will become damaged. See images below. The transmission will need to be removed again; Refer to section "Installation of the Shift Controller" in the Detroit Transmissions Manual.

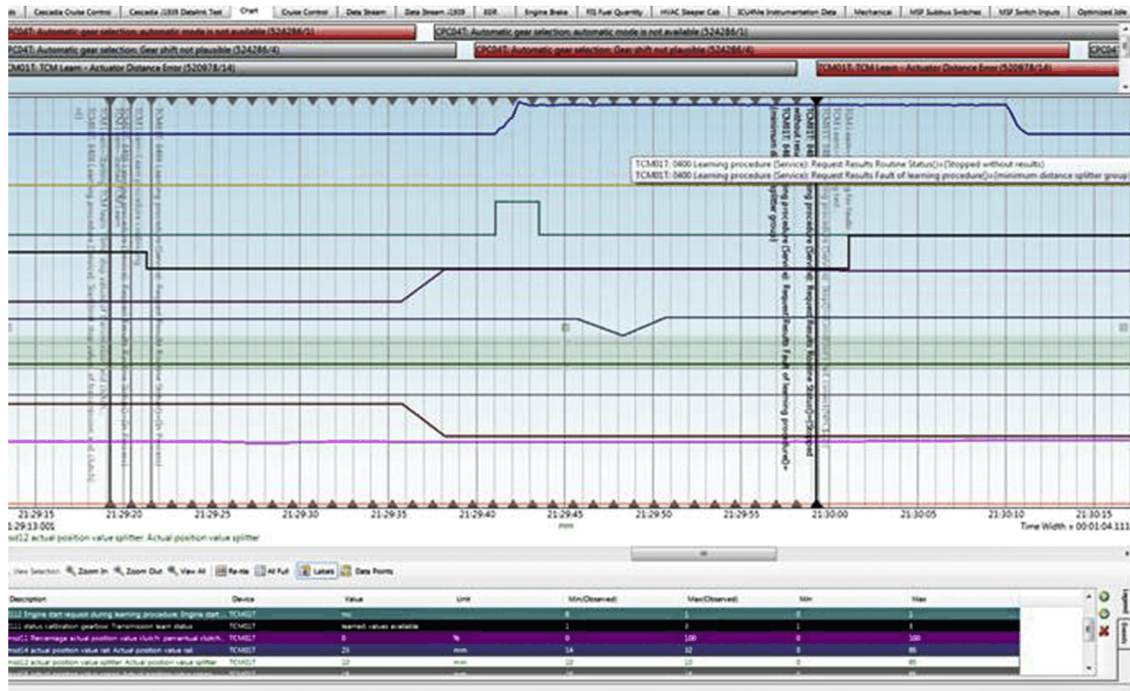
d500326

5. Broken split pin sensor

Failure error: "minimum distance splitter group".
 MSD12: Split will stay at 10mm the entire log file.

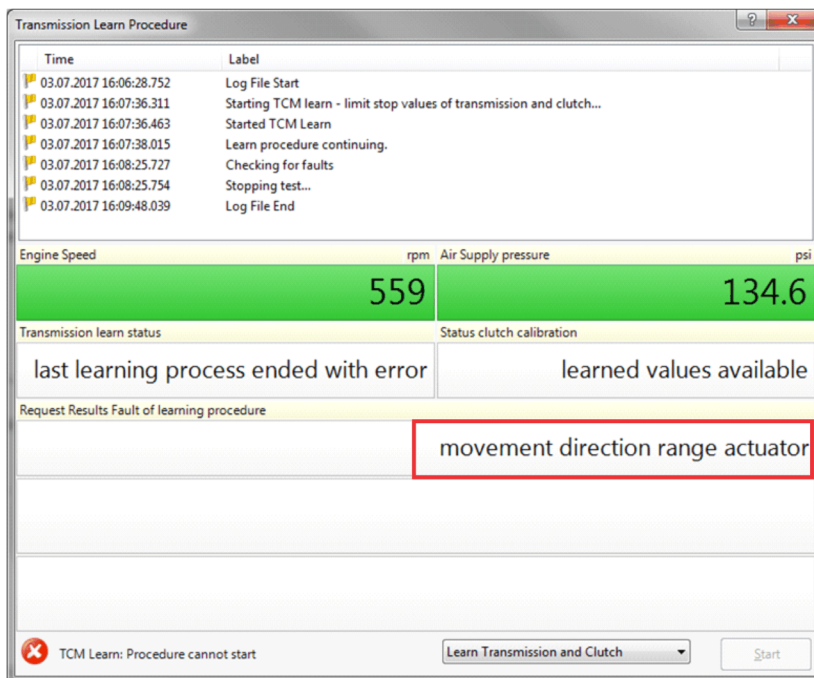
d500336

6. AMT shift controller air lines reversed

The message above; "movement direction range actuator"; indicates that either the air line connections at the AMT shift controller or on the range housing are reversed. Lines are numbered which indicates the port they should connect to.
