Service Information Bulletin

SUBJECT	DATE
SPN 1483 (CPC3) (GHG17)	August 2018

2 SPN 1483/FMI 12 - GHG17

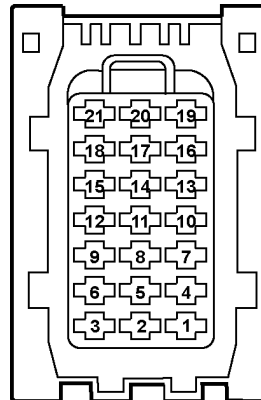
45801

1. Connect DiagnosticLink[®] 8.0 or higher.
2. Turn the ignition ON.
3. Are there any battery voltage faults (SPN 168 FMI any)?
 - a. Yes, troubleshoot battery voltage faults first.
 - b. No; Go to step 4.
4. Is the MCM online?
 - a. Yes, clear all faults. With DiagnosticLink connected, road test vehicle. If fault does not become active during road test, release the vehicle. If fault becomes active during road test Go to step 5.
 - b. No; Go to step 5.
5. Turn the ignition OFF.
6. Disconnect the MCM 21-pin connector.
7. Inspect MCM 21-pin connector for corrosion, water intrusion or pin damage. Is damage is found?
 - a. Yes; repair as necessary.
 - b. No; Go to step 8.
8. Turn the ignition ON.
9. Measure the voltage between MCM 21-pin connector pins 7, 11, 12, 14 and 15 (ignition/battery voltage) and ground. Is the voltage less than 11.5 volts?

- a. Yes; restore voltage to MCM 21-pin connector pins 7, 11, 12, 14 and 15. Refer to EZWiring for detailed schematic information.
 - b. No; Go to step 10.
10. Turn the ignition OFF.
11. Measure the resistance between MCM 21-pin connector pins 5, 6, 8 and 9 (negative battery post). Is resistance greater than three ohms?
 - a. Yes; restore battery ground to MCM 21-pin connector pins 5, 6, 8 and 9. Refer to EZWiring for detailed schematic information.
 - b. No; repair PTCAN harness between the MCM and the PTCAN (Yellow) Star point connector. Refer to EZWiring/Drawing Type: Schematics Diagrams/Vehicle Sub-System:/Data link and Diagnostics (J1587 and J1939) module for detailed schematic information. See schematic location example below.
